Durango, Colorado, Processing and Disposal Sites

This fact sheet provides information about the Uranium Mill Tailings Radiation Control Act of 1978

Title I processing and disposal sites located at Durango, Colorado. These sites are managed by
the U.S. Department of Energy Office of Legacy Management.

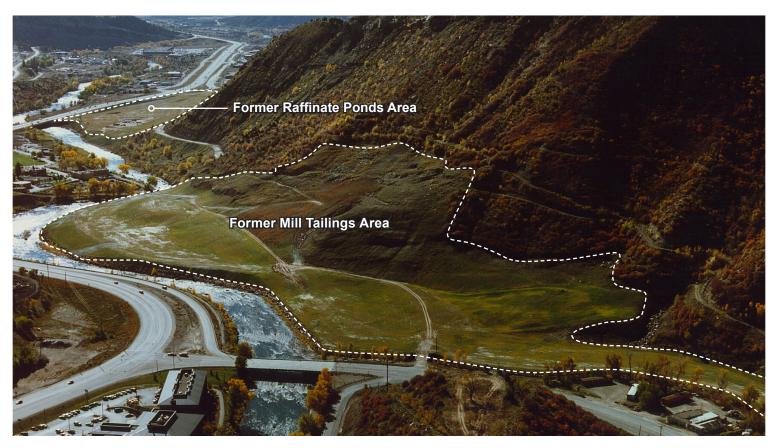
View of Durango, CO, Remediated Processing Site (1991)

Long-term soils management is required at the former processing site where residual contaminated soils were left in place in two areas along the bank of the Animas River and in unreachable areas of windblown contamination on the adjacent slope of Smelter Mountain. DOE contoured and reseeded the former mill tailings and raffinate ponds areas with native grasses.

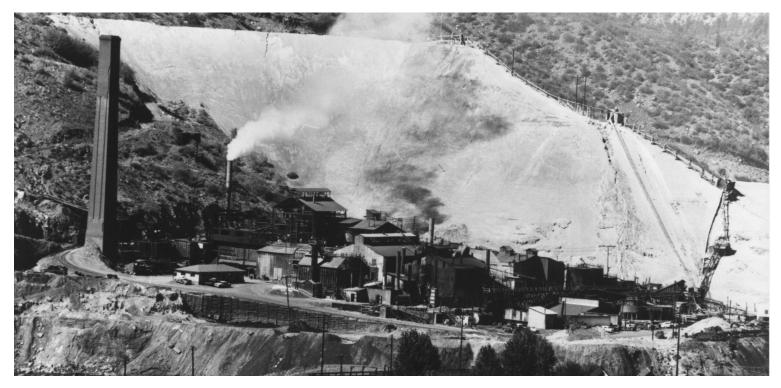
Durango mill during active operations (date unknown). The smokestack for the old lead smelter is to the left, with the large tailings pile and conveyances across the center.
